# TESTING REGIME

## EXAMPLES OF PERFORMANCE TESTING

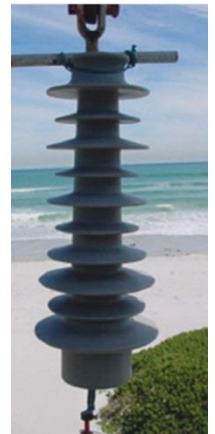
EMCPA's LPI36-1100 (36kV line post insulator) underwent very heavy pollution and natural ageing coastal testing at the Koeberg Insulator Pollution Test Station (KIPTS) in South Africa. Both winter and summer cycles were successfully completed with the insulator achieving an extreme pollution evaluation at 22kV. KIPTS is regarded as one of the most rigorous test regimes globally delivering results that can be relied on as indicative to real world long term performance. This is a recognized real world equivalent of undergoing a 5000 hour salt fog laboratory insulator test.

ACCEPTANCE CRITERIA	RESULT		COMMENT
	L-M	H-VH	
No more than three over current trip outs	Pass	Pass	None
No signs of material erosion deeper than 2mm	Pass	Pass	None
No signs of tracking in the material	Pass	Pass	None
No signs of corrosion that has exposed the base metal or can lead to failure of hardware	Pass	Pass	None
The material analysis completed			None
